By Don Talend

Military Reserve Center Preserved

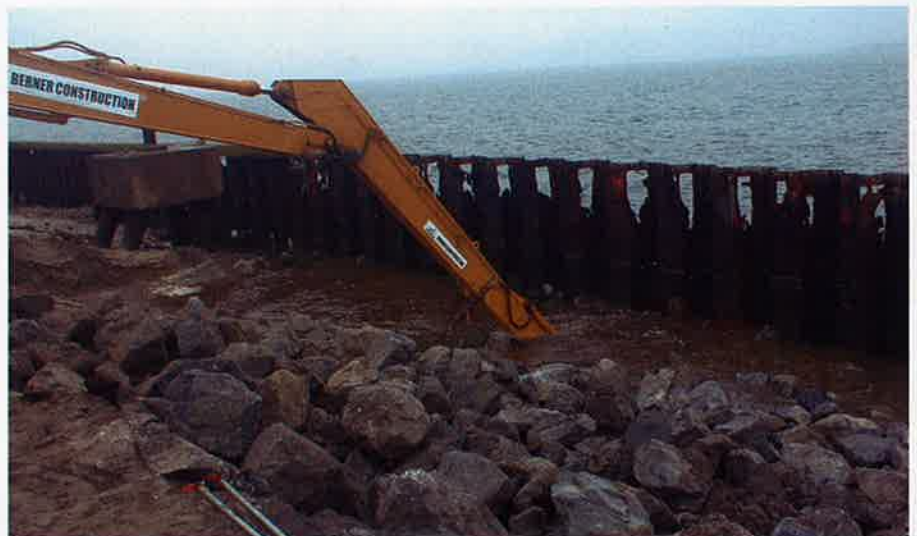
The first task was removal of the steel sheet seawall, which had badly deteriorated.

Berner Construction was contracted by one of the Navy's Environmental Military and Construction contractors to provide labor, equipment, and supervision to replace 1,200 feet of revetment seawall. The company started work in June 2006. The first task was to demolish the existing seawall. "Over time, holes rusted through the wall and waves would come in and erode the shoreline," notes Irely. "They tried to bolster it with old blocks of concrete. During the reconstruction effort, we pulled out the concrete blocks, regraded the shoreline, and rebuilt the armor rock revetment wall."

Removal of the existing concrete cap on the sheet pile wall followed before the steel sheet pile wall was removed above the mud line.

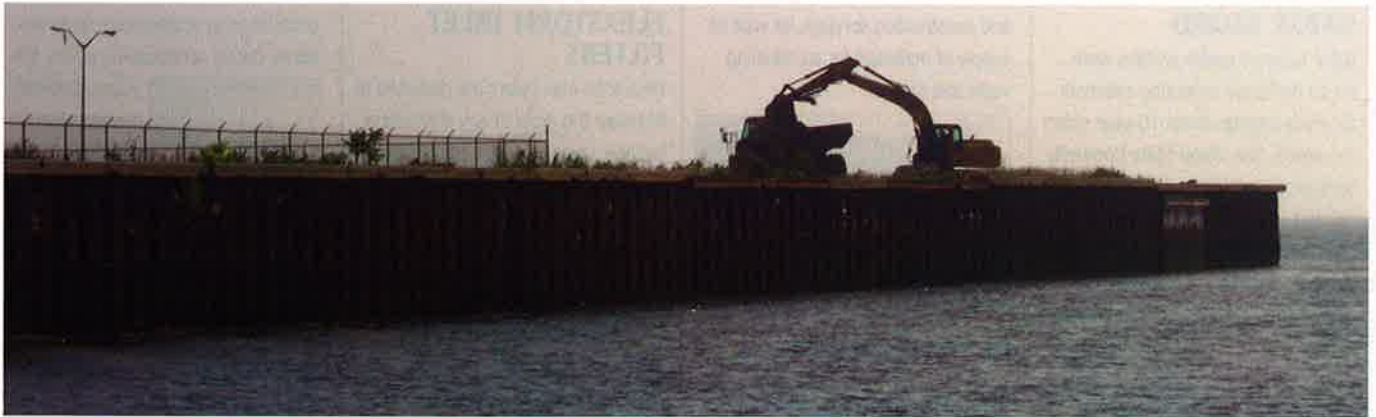
The shoreline at the Floyd Bennett Field Marine Corps Reserve Center in Brooklyn, NY, recently required stabilization. A deteriorating steel wall (above) was replaced with a stone revetment wall (below).

tially collapsed. Shoreline erosion had begun to occur as a result, causing some damage to a reserve center parking lot. "The wall had deteriorated to the point where it was falling in on its own weight; the Navy wanted to mitigate that," Irely says. "The seawall was made from steel sheeting that is three-eighths of an inch thick and standing above the water line 15 or 20 feet high. Predominately, the job was hazard mitigation."

With the existing structure removed, the team went to work on constructing a front-sloping stone revetment seawall that would stabilize the shoreline for many years in the future. The underwater base of the seawall was to be sloped to break the wave action and prevent erosion. First, the existing side slope was regraded. Then, nonwoven geotextile fabric was installed to the mud line.
