# Military Reserve Center Preserved

Shoreline stabilization at historic Floyd Bennett Field in New York requires creative scheduling around tides to halt worsening erosion

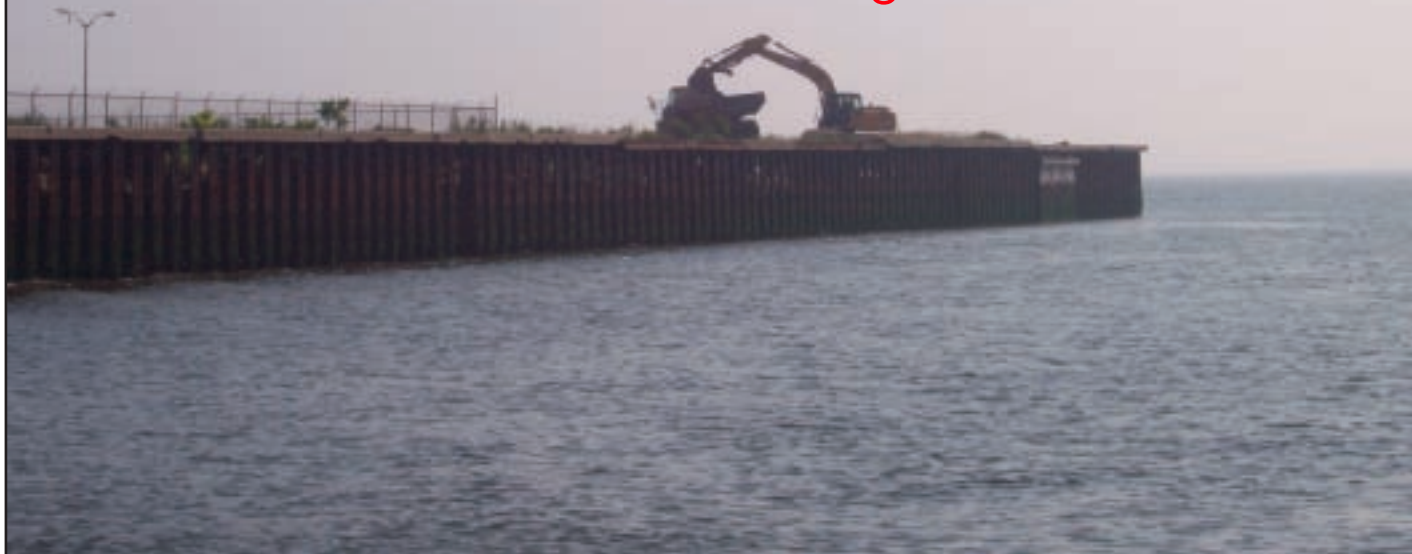
The shoreline at the Floyd Bennett Field Marine Corps Reserve Center in Brooklyn, N.Y., recently required stabilization after experiencing considerable erosion that damaged a parking lot and posed a safety hazard. Photo credit: Berner Construction, Inc.

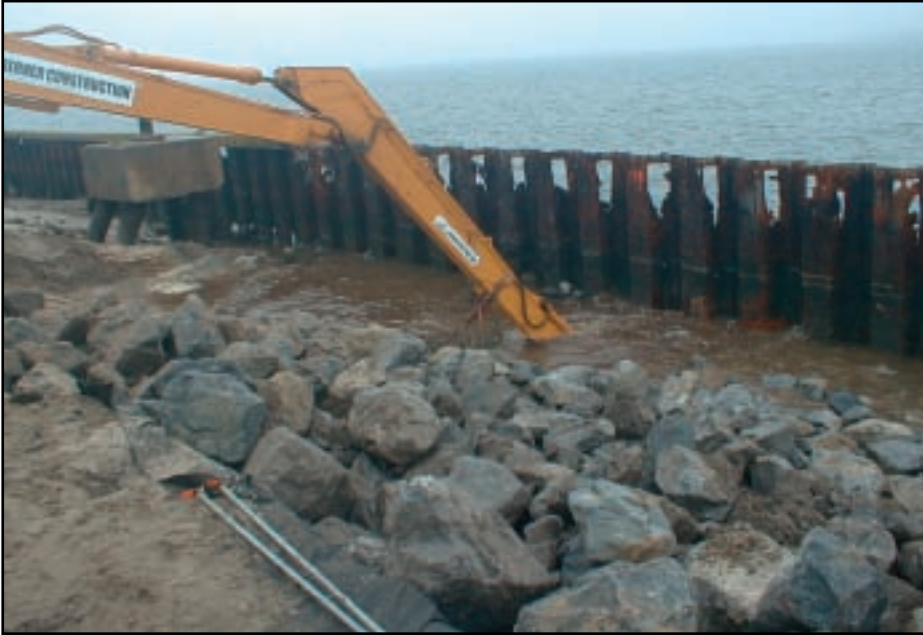
Long past its prime as a major military base, Floyd Bennett Field began showing its age in recent years. An old steel sheet pile seawall along the shoreline had deteriorated over the years to the point where it had partially collapsed. Behind the steel sheet pile wall, the

The first task was removal of the steel sheet seawall, which had badly deteriorated. Photo credit: Berner Construction, Inc.

shoreline was eroding away as a result of wave and tidal actions. The Navy not only was concerned that the deteriorating sheet pile wall posed a safety hazard but also saw that a reserve center parking lot was threatened. "The wall had deteriorated to

the point where it was falling in on its own weight," Irely says. "The sea wall was made from steel sheeting that is three-eighths of an inch thick and standing above the water line 15 or 20 feet. Predominately, the job was hazard mitigation."

Berner Construction was contracted by TN and Associates to provide labor, equipment and supervision to replace 1,200 feet of revetment seawall, and started work in June 2006. The first task was to demolish the existing sea wall. "Over time, holes rusted through the wall and waves would come in and erode the shoreline," notes Irely. "They tried to bolster it with old blocks of concrete. During the reconstruction effort, we pulled out the concrete blocks, regraded the shoreline and rebuilt the armor rock revetment wall."

The construction team first installed a silt fence for erosion control. Then wood, asphalt and concrete debris were removed from behind the existing sheet pile wall. Removal of the existing concrete cap on the sheet pile wall followed before the steel sheet pile wall was removed above the mud line.

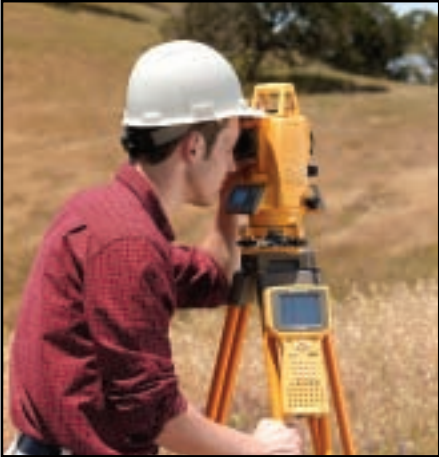
**A Topcon GTS-236W Electronic Total Station and RL-H3C Rotating Laser were used to hold and check grade during the process of placing rock in 25-foot sections. Photo credit: Topcon Positioning Systems.**

The cross-section of the slope was 30 to 35 feet long, with a 3-foot delta. A Topcon GTS-236W Electronic Total Station and RL-H3C Rotating Laser were used to hold grade and then check the grade to make sure that the slope was not overfilled or underfilled. Berner’s total station was part of Topcon’s GTS-230W Series, the first electronic total stations with wireless operation that eliminates

“We’d put two grade stakes down: one at 25 feet down and one at 15 feet down and we’d grade to them,” notes Irey.

“At the end of the day, you’re an artist and you want your work to look good. We would check the subgrade with the total station before we placed the material and then we would check it periodically before we would place the stone. About once every three days, we would put a guy in waders and a life vest at low tide to check the grade from the water’s edge to be sure that we were meeting the intent of the design.”
